Initial Inspection Report

Volkswagen Scirocco TSI 2009 Reg No:

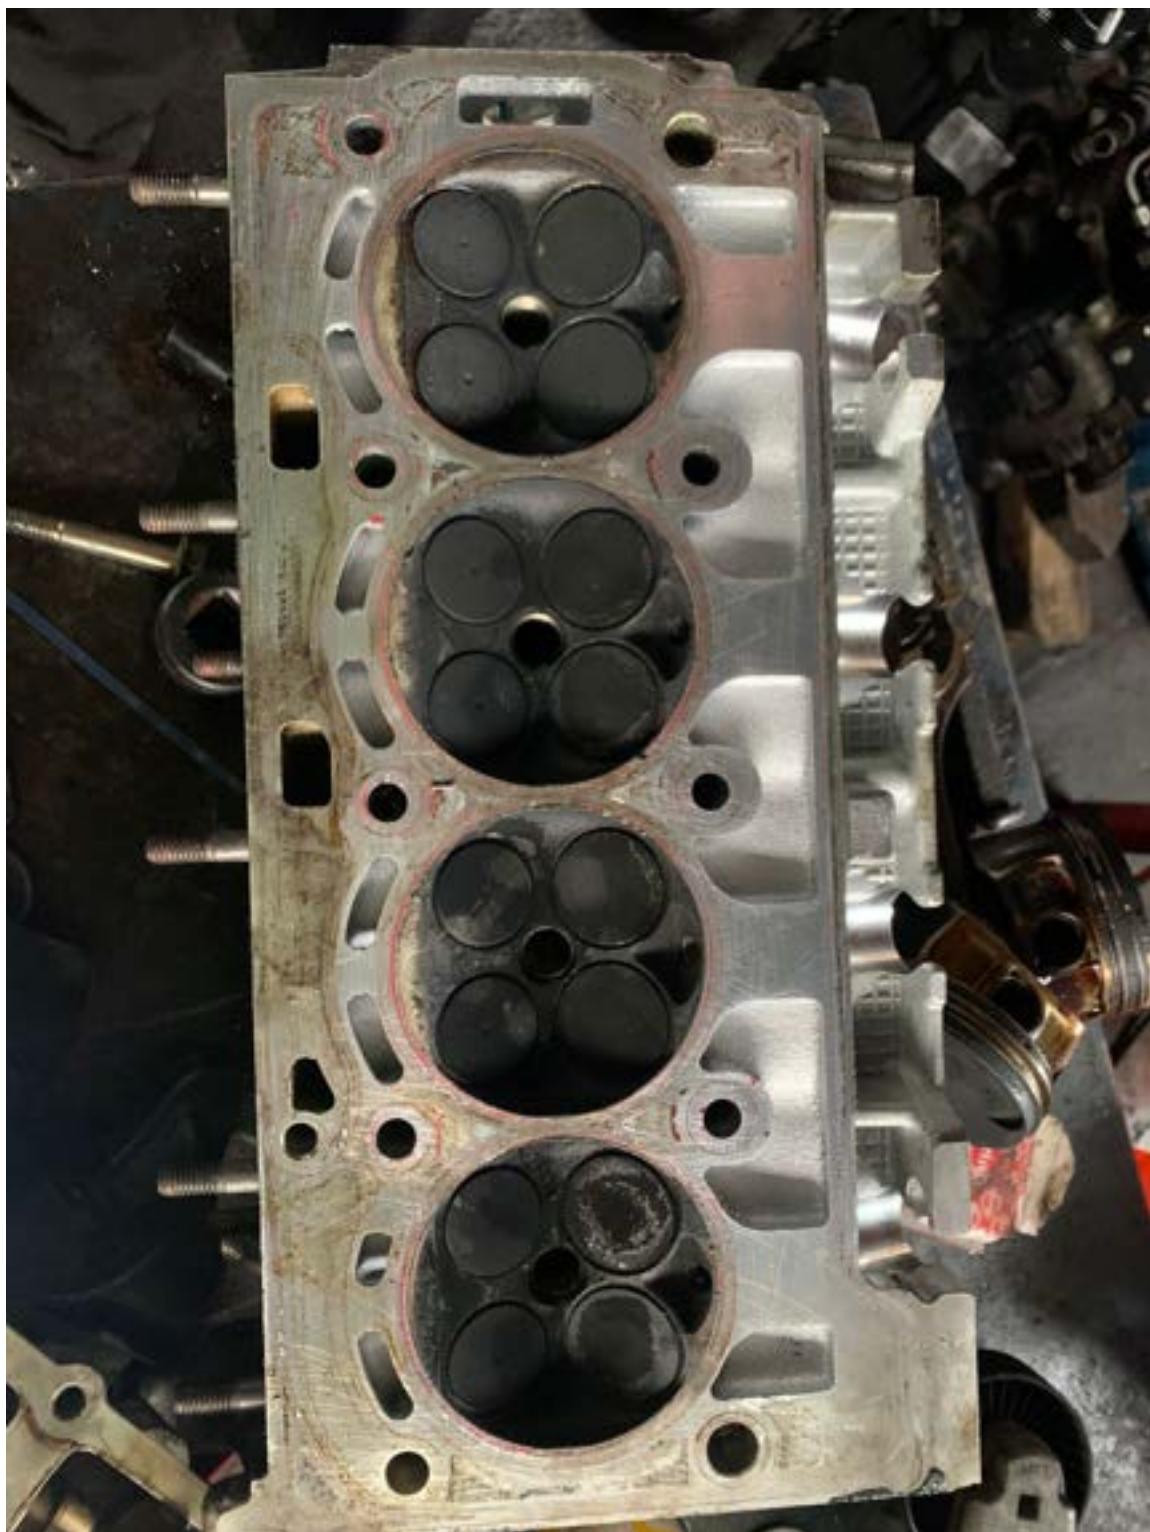
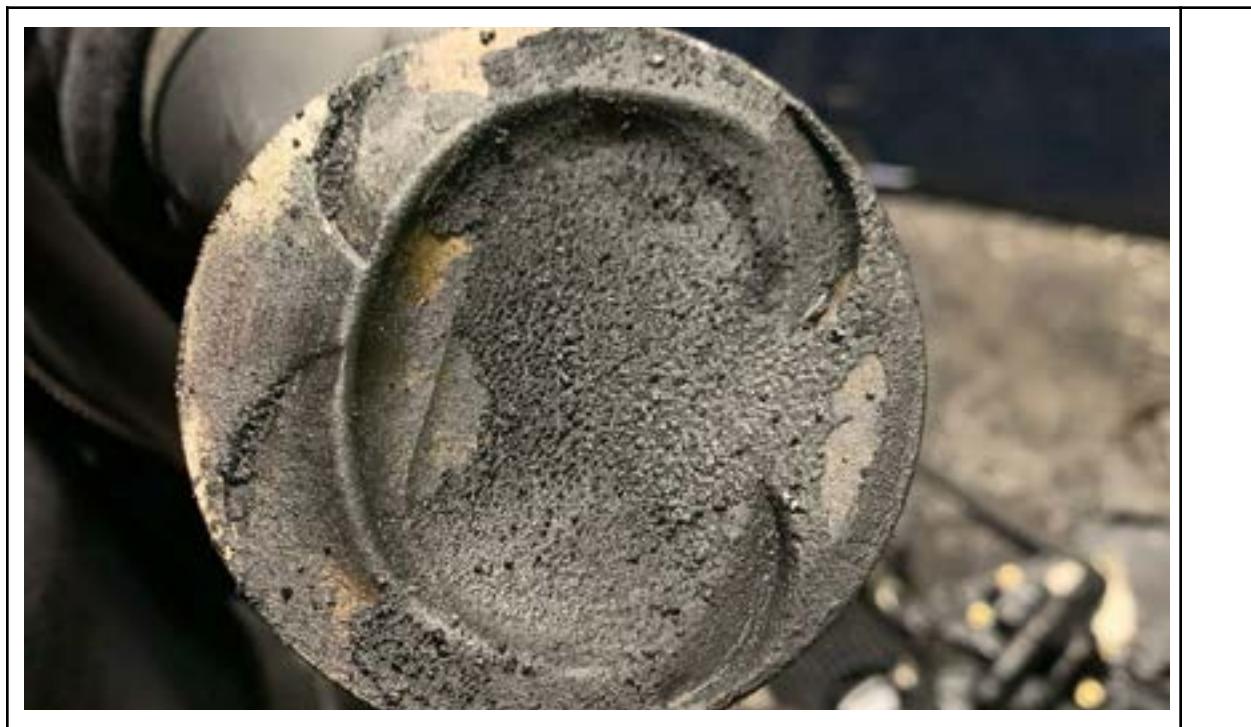
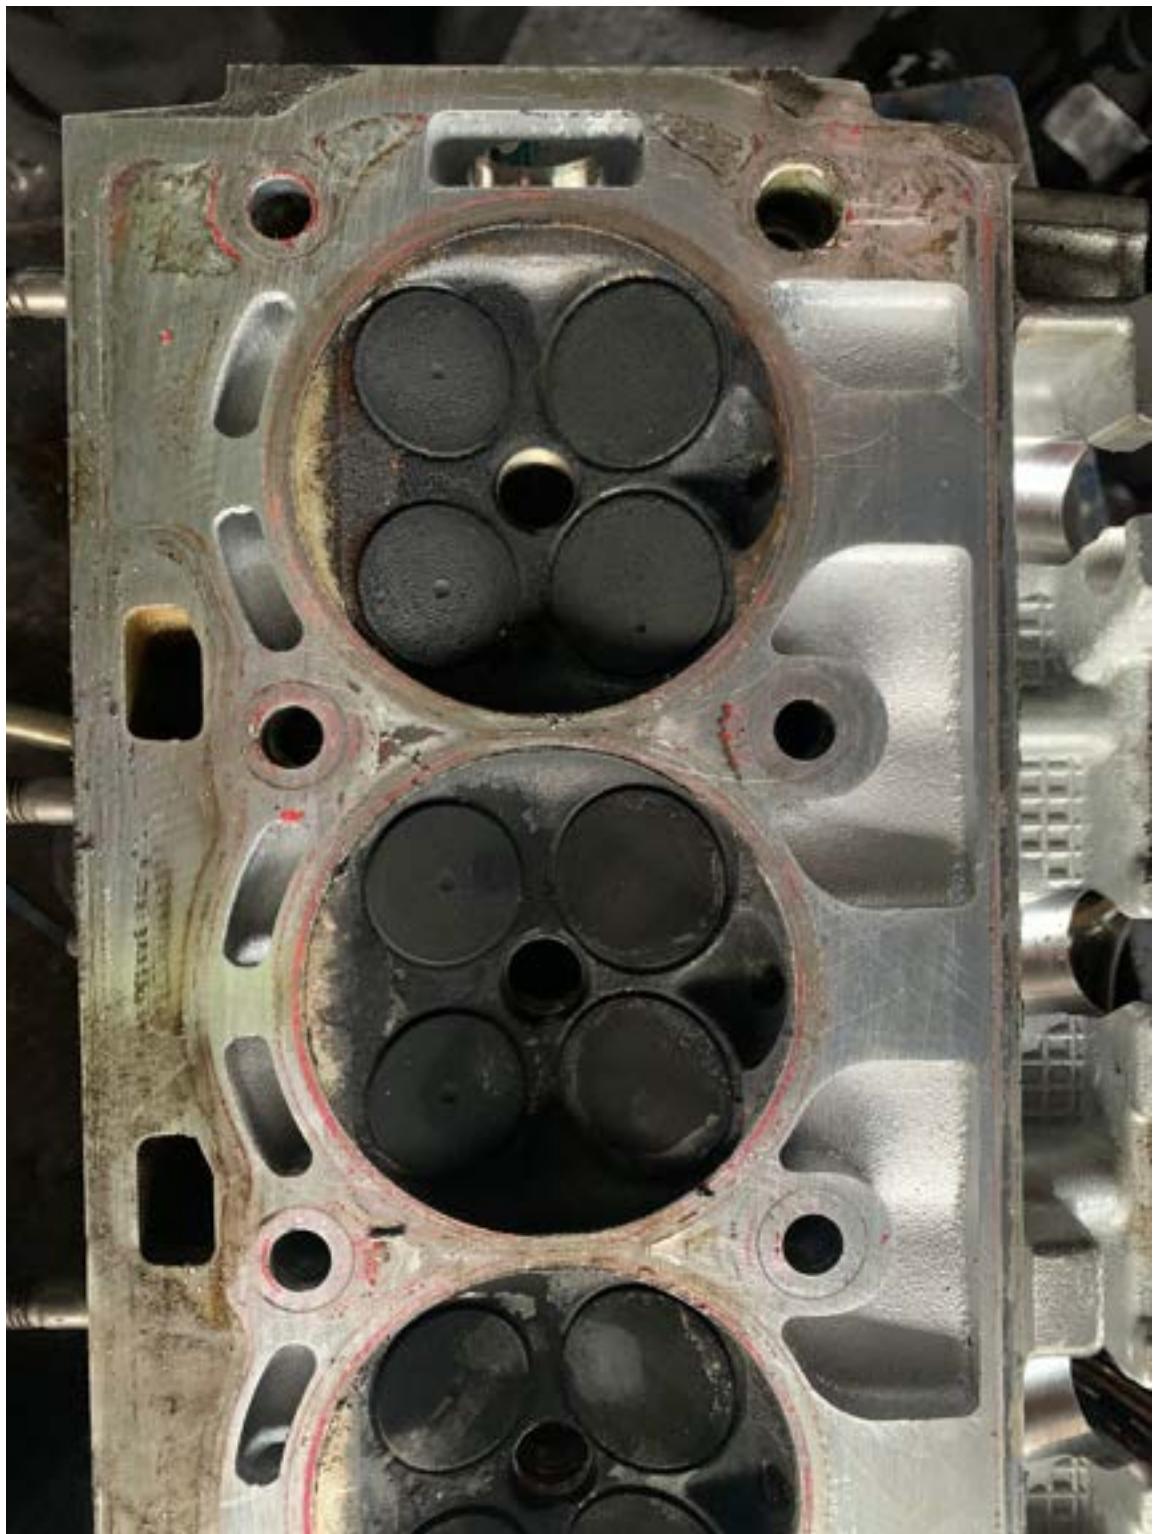
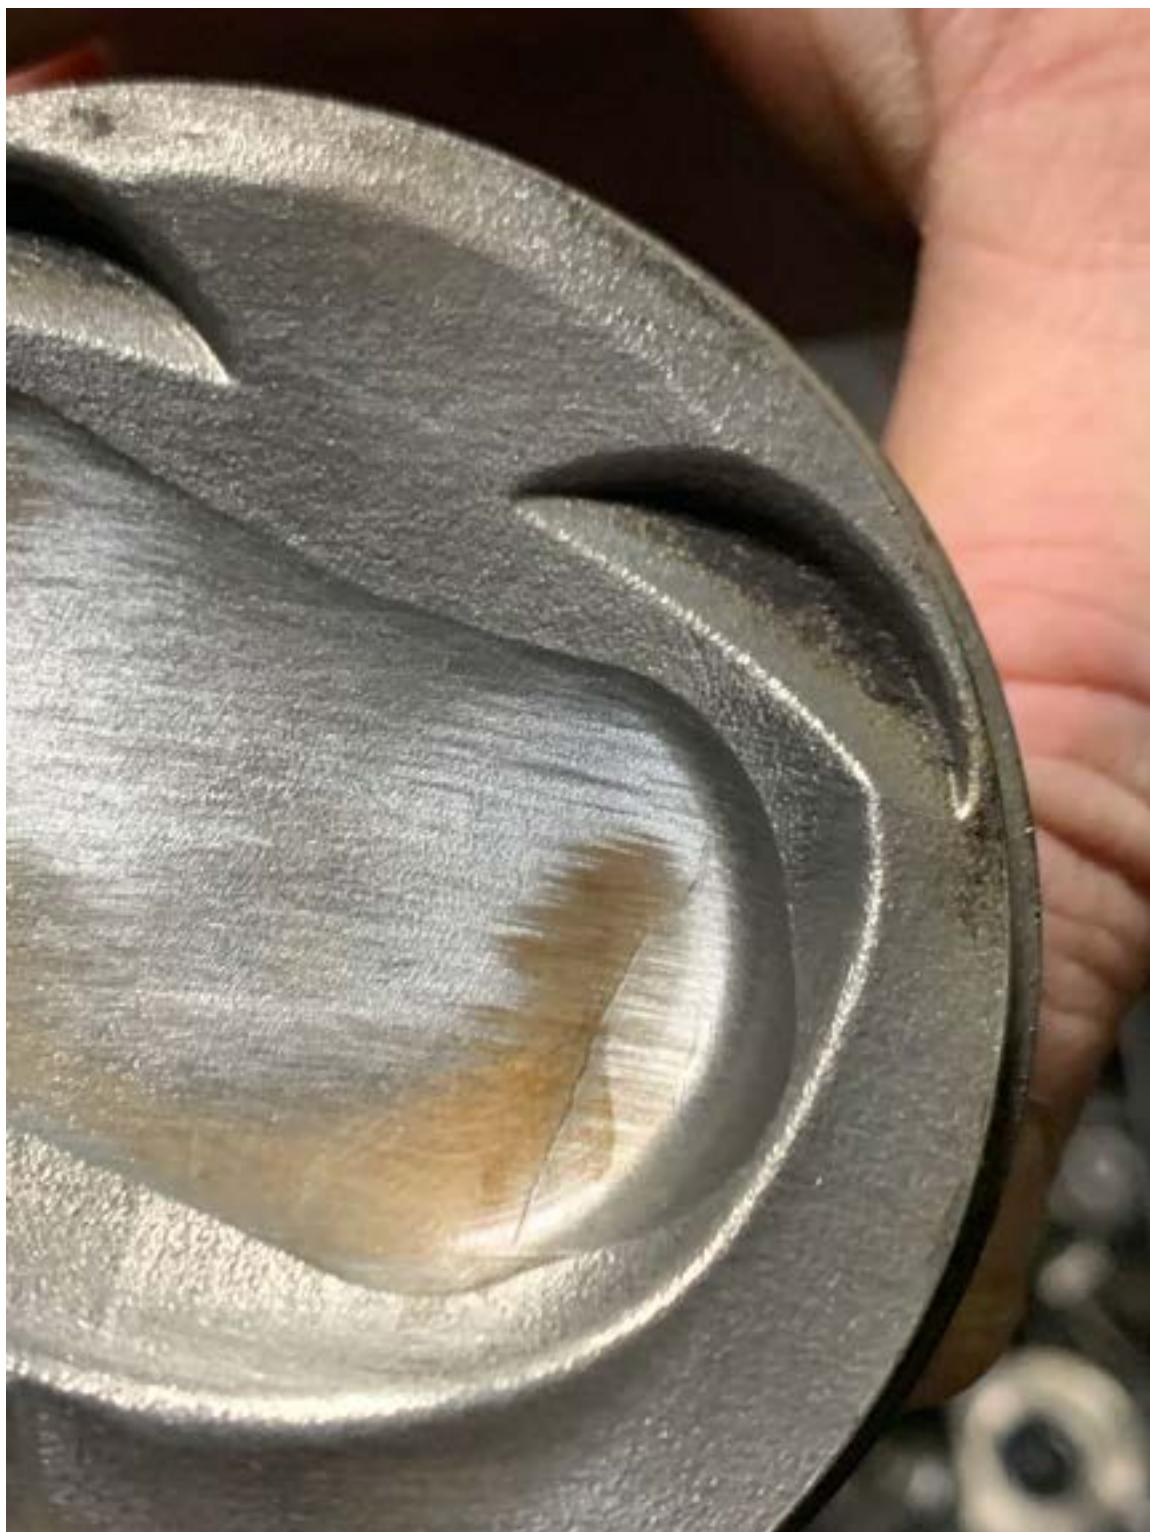
<u>Report (Please see attached images to the bottom of document)</u>	
All injectors pour too much fuel. This can be seen from the large amount of soot on the cylinder head.	1
Loss of compression on all cylinders due to crack in piston/s.	2
Severely worn/broken piston rings	3
Scored & damaged pistons	4

Most probably the main cause of failure were the injectors pouring too much fuel into the cylinders, resulting in an undesired fuel-air mixture, higher combustion temperature, more stress on the internal components, soot and gunk build-up on the head/piston. As well as fuel mixing in with the oil, causing loss in lubrication qualities of the oil.

Injectors - we **strongly recommend** that the injectors are replaced as we believe that they are the reason the engine has failed. Given the high cost to replace we often offer a 2-week time period to replace the injectors without voiding the warranty.

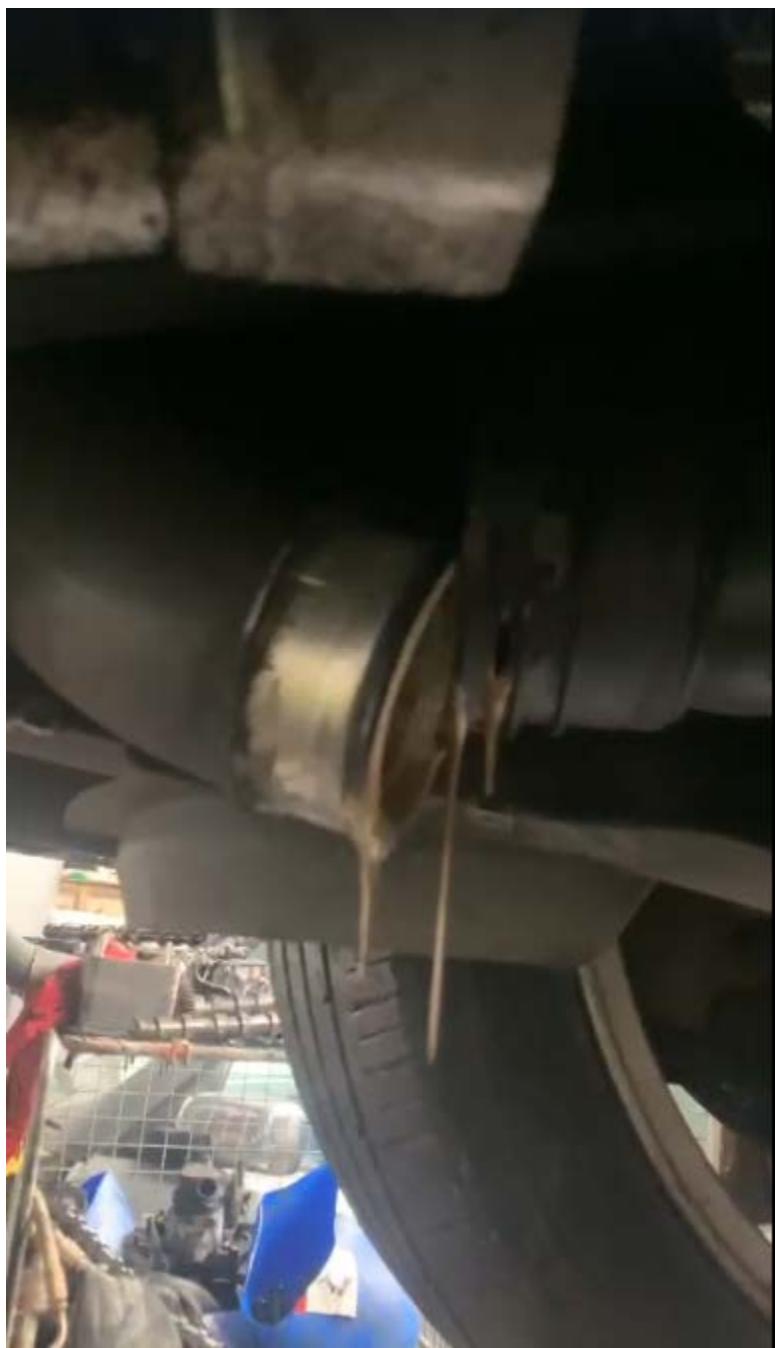
Turbo mixing oil and coolant then throwing it out to the intercooler	5
Head cylinder incorrectly skimmed, shown by the heavy scoring on the cylinder head. As if someone used sandpaper.	6
