Registration:	Removed	<u>Condition reported by Customer</u> Timing chain snapped, needs replacement, potentially needs valve replacement/resetting
Mileage:		
Engine/Code:	BKD	
VIN		
Make		
Model		
DOI	Sep 13, 2022	
Quote	£1,800

Inspection Report - Removed AUDI A3 S LINE TDI S/BACK (2008)

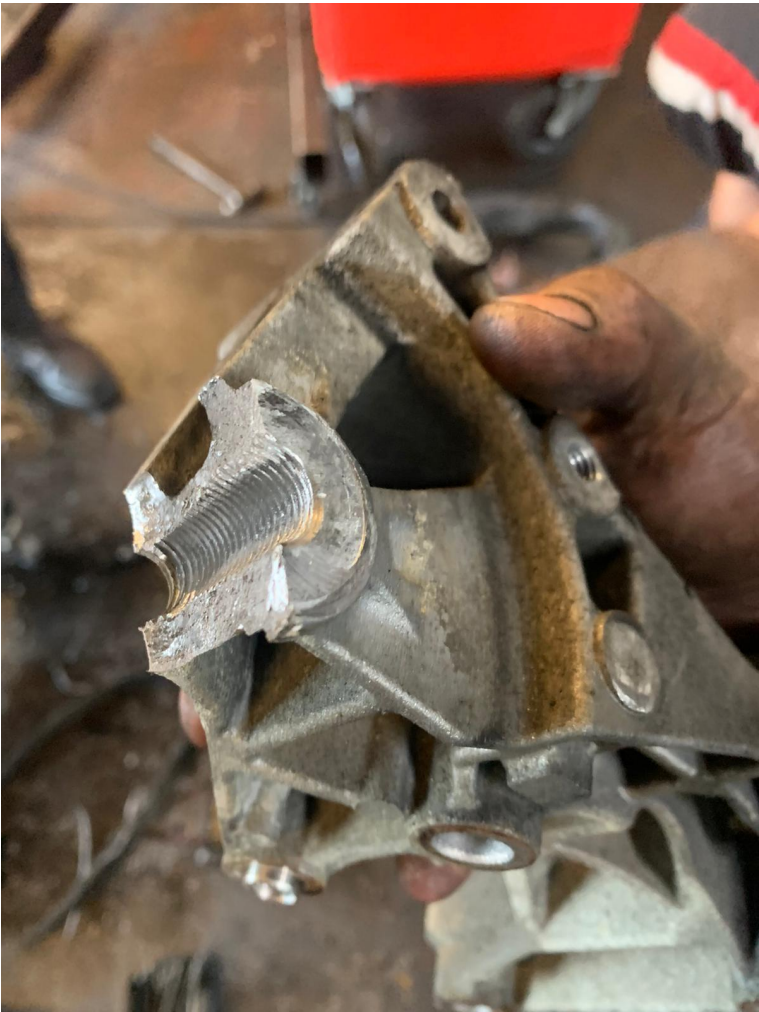
Engine Mount	Engine mount ripped into two pieces.
	Non-serviceable ▾	
	Main cause of failure	The reason this may have happened is because It was not torqued at all to the chassis. Given a little speed and a bump the engine mount has moved up and slammed back down onto the chassis causing it to rip a hole in the block. Snap the mount & stick it into the timing.

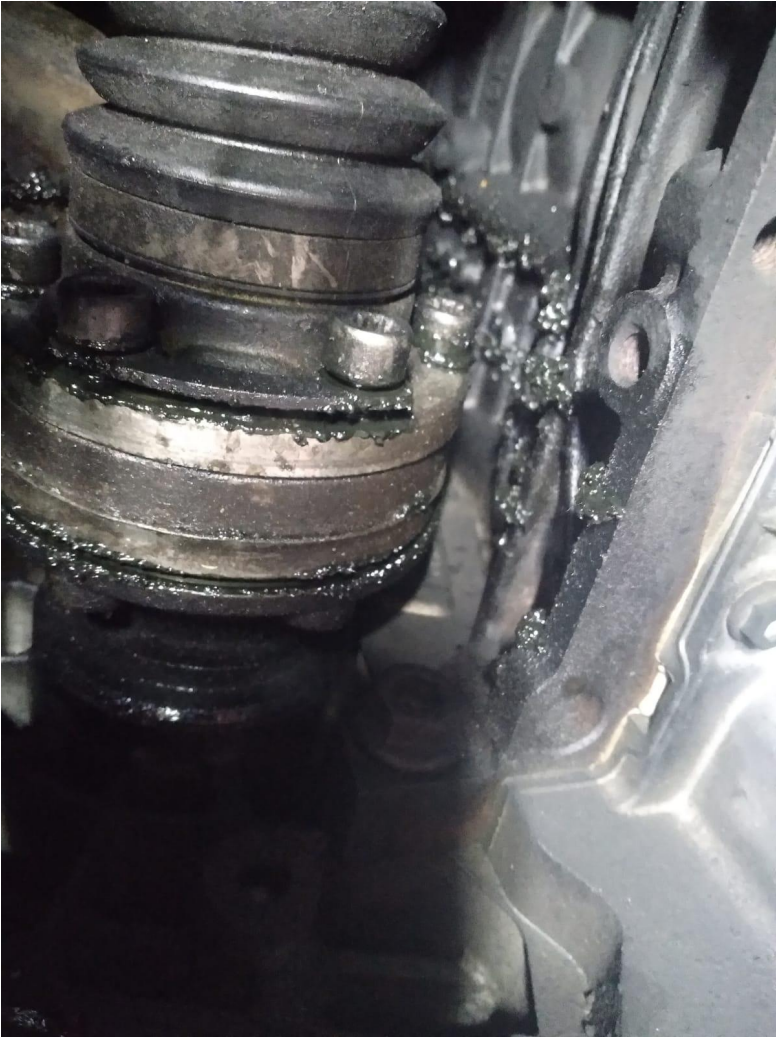
Driveshafts	Driveshafts & underside not torqued at all/. Lubricant leaking from CV joints.
	Serviceable ▾	
		<p>This became evident when taking the engine out as we had to disconnect the driveshafts.</p> <p>Driveshafts should be serviced along with the CV joints to ensure that they are well lubed and have no leaks.</p>

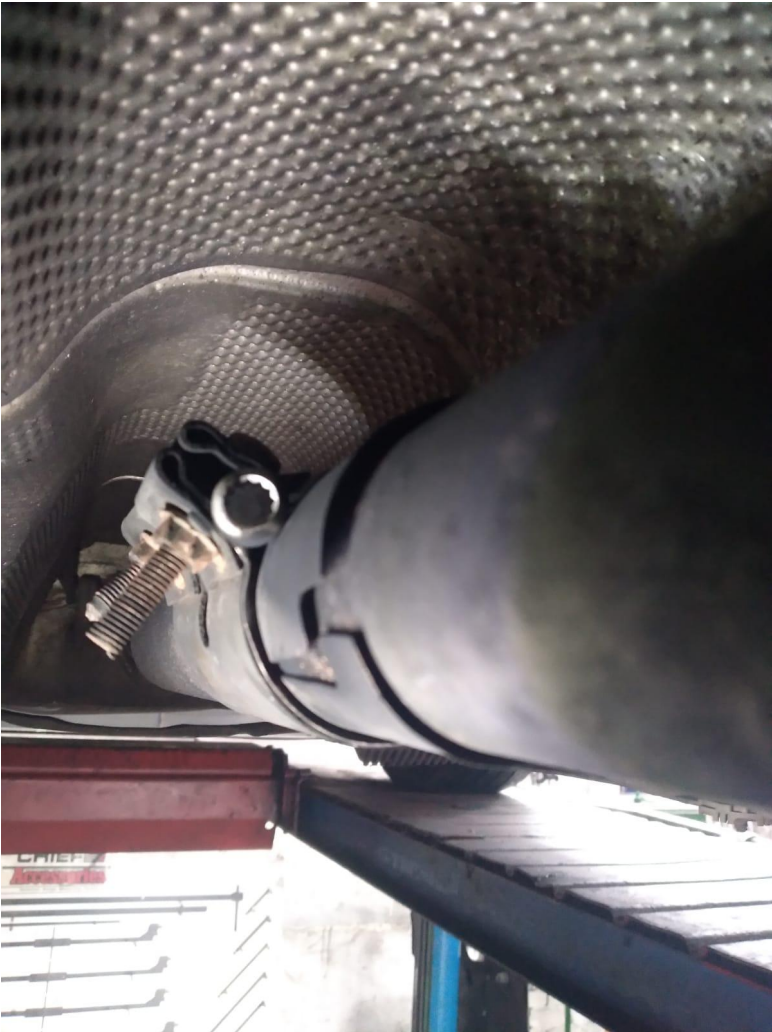
Exhaust Clamp & System	Poor work done to the car, nothing is torqued appropriately.
	Serviceable ▾	Clamp is floating about not holding the exhaust together as it should.
		Exhaust needs some additional work to ensure that it's secure & torqued appropriately.

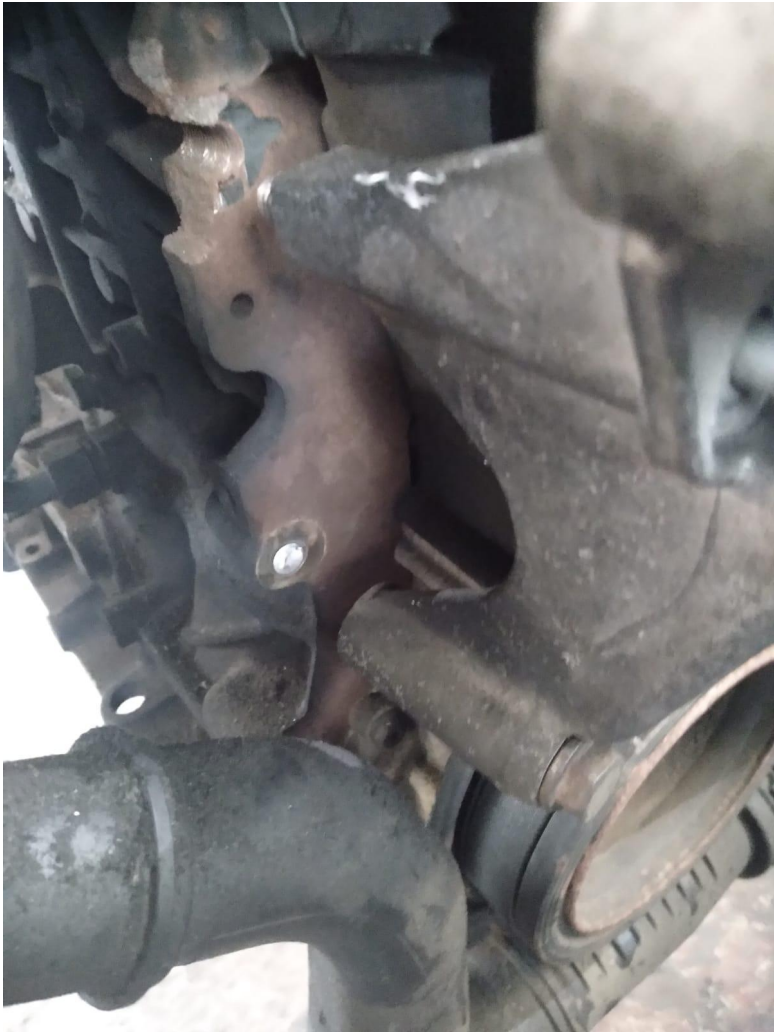
Engine Component	Status	Notes
Engine Block	Non-servic... ▾	Engine block has a hole ripped out of it from the timing chain bolt, welding will not provide a warrantable service.
Cylinder Head	Serviceable ▾	No major damage
Crankshaft	Serviceable ▾	No major damage
Con-rods	Serviceable ▾	No major damage
Pistons	Serviceable ▾	No major damage

Timing Tensioner	Tensioner has been ripped off the engine leaving one bolt inside.
	Non-serviceable ▾	Block needs to be replaced as we cannot warrant welding for a place like this.
